## **VAC System Tortesimal: Alternative for the Treatment of Complex Wounds in the Absence of Commercialized Devices**

**Jorge Eduardo Barragán-Morales<sup>1</sup>, Ana Luisa Bugarín-Arellano<sup>2</sup>, Daniel Balderas-Anzures<sup>3</sup>**

<sup>1,3</sup>Servicio de Cirugía General del Centro de Alta Especialidad “Dr. Rafael Lucio”

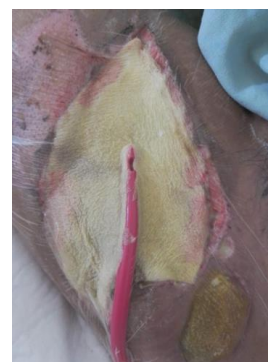
Figure 4

abdomen, pelvic fracture, which required laparotomy; splenorrhaphy, cystorrhaphy and right oophorectomy. In addition, with a complex bloody wound in the left pelvic limb with abundant loss of substance that was treated in a first surgical period with closure and mobilization of local flaps; After several days of evolution, the wound suffered suppuration and dehiscence (*Figure 1 A and B*), so it was decided to carry out surgical debridement and the need to apply subatmospheric pressures. However, due to the high cost and lack of intermittent vacuum therapy marketed, we opted for an artisanal alternative with material for wound healing (gauze and sodium chloride), a sterile sponge, a vacuum tube (Nelaton probe) and a waterproof plastic site (Steri-Drape) for coverage with the dimension corresponding to the size of the wound. (*Figure 2*) Once the wound and the surrounding tissue were prepared, the sponge was placed covering the entire wound without exceeding it, dead spaces were avoided, incrustado between the sponge, the suction tube (Nelaton probe) was placed or previously fenestrated and then another cover again with another sponge is é ril, and the adhesive band (Steri-Drape) <sup>®</sup> is placed (*Figure 3*). The drain tube (Nelaton wave) was then connected to a suction tube which was connected to a negative pressure and suction system adjustable to a vacuum pump. Subsequently, he checked the absence of leaks through the (<sup>®</sup> Steri-Drape) by observing the completely collapsed sponges immediately

when aspiration began (Figure 4). The cures and changes of the artisanal ACV were performed<sup>®</sup> every 48 hours for 14 days, finally the absence of infection was corroborated with culture of the wound without development, and epifast cultured skin allograft was placed, favoring wound closure by second intention leaving its dimiclium with a completely epithelialized wound.<sup>®</sup>
